Manhole Inspection Summary

Manhole # S33UU1020MH

Insp Date: **3/19/07 9:32 AM**

Location Address: **5001 SPRINGLAKE WAY**

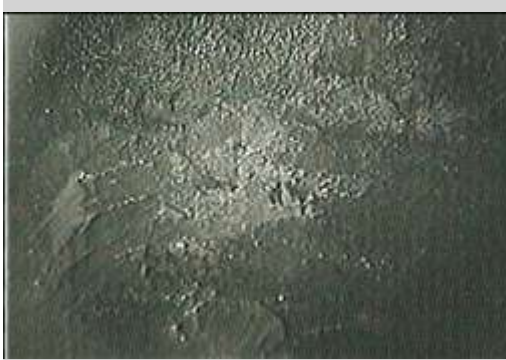
Defect

Barrel infiltration.

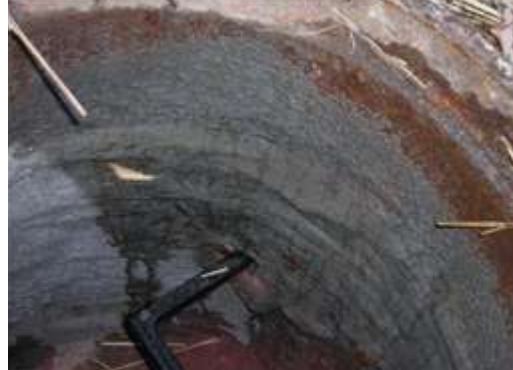
Defect

Frame Offset: **0** (in.) Condition: ☐ Sound ☐ Cracked ☒ **Leaks**

Frame leaks. Adjustment and Corbel infiltration.

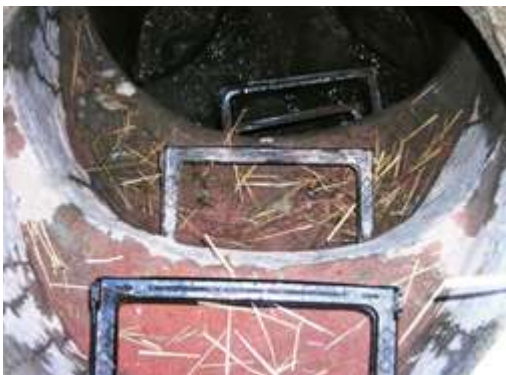
Defect

Adjustment, Corbel, and Barrel infiltration.

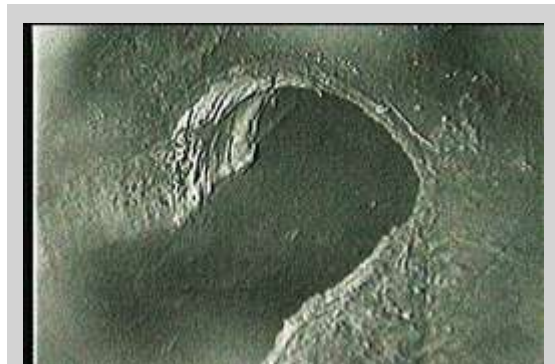
Pipe In @ 3 O'Clock

Infiltration: **Evidence**
